## APPLICATION STORY

### FLIR Systems R&D camera used to detect metal fatigue damage in construction steels

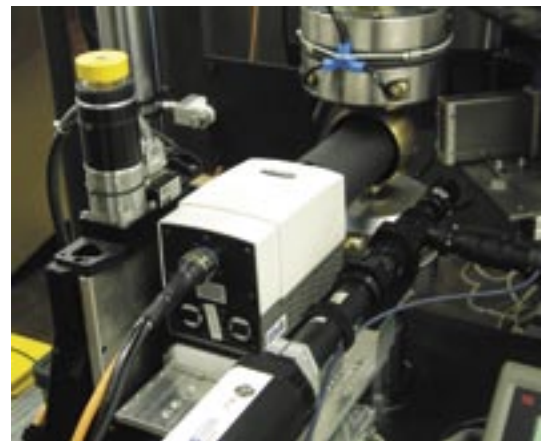
Phoenix IR camera placed on testbed, specimen is covered by messing sphere for thermal shielding

The goal of the long-time scientific project is to thermographically detect, describe and eventually quantify fatigue phenomena such as cyclic plasticity, slip bands and microcracks. The test setup consisted of a servo-hydraulic testing machine connected to a FLIR Systems Phoenix infrared camera placed on an automated positioning system. An additional video-light microscope is used for parallel light-microscopic investigation. A series of uniform pieces of general purpose construction steel with a thickness of 20 mm served as specimen. The pieces were subjected to fatigue tests with sinusoidal loading at different load levels (stress amplitudes). The fatigue loading was interrupted every 20,000 load steps. A microscopic scan of the specimen's surface was then triggered. Before each scan, a series of infrared images was taken during the applied loading. Fatigue tests were finished after  $10^6$  load cycles or upon presence of a macrocrack in the specimen. The only preparation of the steel specimen consisted of the application of some emissivity coating to avoid reflectivity. The researchers used the lock-in thermography method. The mechanical loading of the testing machine was thereby used to generate a periodic temperature in the tested specimens. An in-house developed data processing program minimized the detector "noise" to better discern the very minimal temperature variations.

As temperature differences caused by cyclic plasticity are very small, the testing required a camera able to measure and image the temperature variations of a few mK. The infrared camera used during the testing was a FLIR Systems Phoenix 640x512 pixel with an InSb detector, equipped with a 25 mm lens and extender ring. During the testing, the camera scanned at an integration time of 2 milliseconds and at a frame rate of 412.5 Hz. As the test specimen was moving, a motion compensation scheme up to sub-pixel level was implemented. Further data processing included two-point non-uniformity correction, calibration, filtering and a separation of thermoelastic and thermoplastic temperature variations.

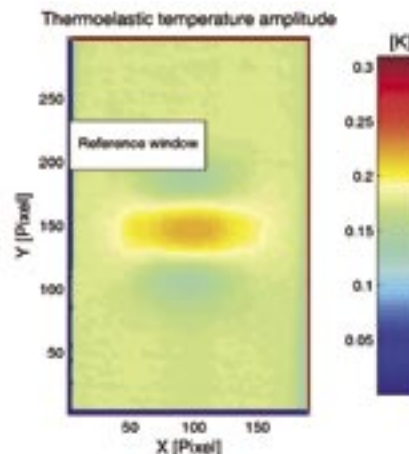
Visualization of thermoelastic temperature variation of the specimen

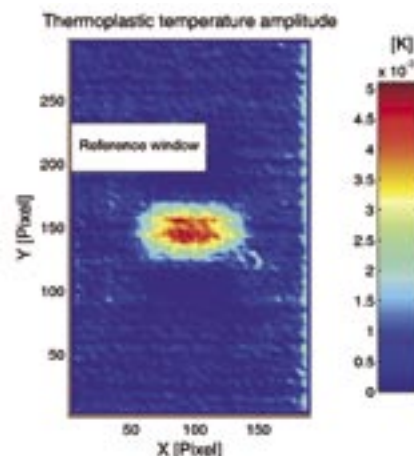
Separated temperature change up to 5 mK due to local plastic deformation in course of the fatigue loading

The infrared images of the fatigue-loaded specimens revealed the early development of highly localized cyclic plasticity even before slip bands can be seen under the microscope. "Temperature changes due to cyclic plasticity can be measured by an infrared camera," says engineer Justus Medgenberg, of the Braunschweig University's Institute for the rehabilitation of buildings and structures, "and cyclic
