APPLICATION STORY

Opening up the Corridor: Serbian Railways use FLIR Systems E-series camera for maintenance and inspection of passenger wagons wheel parts

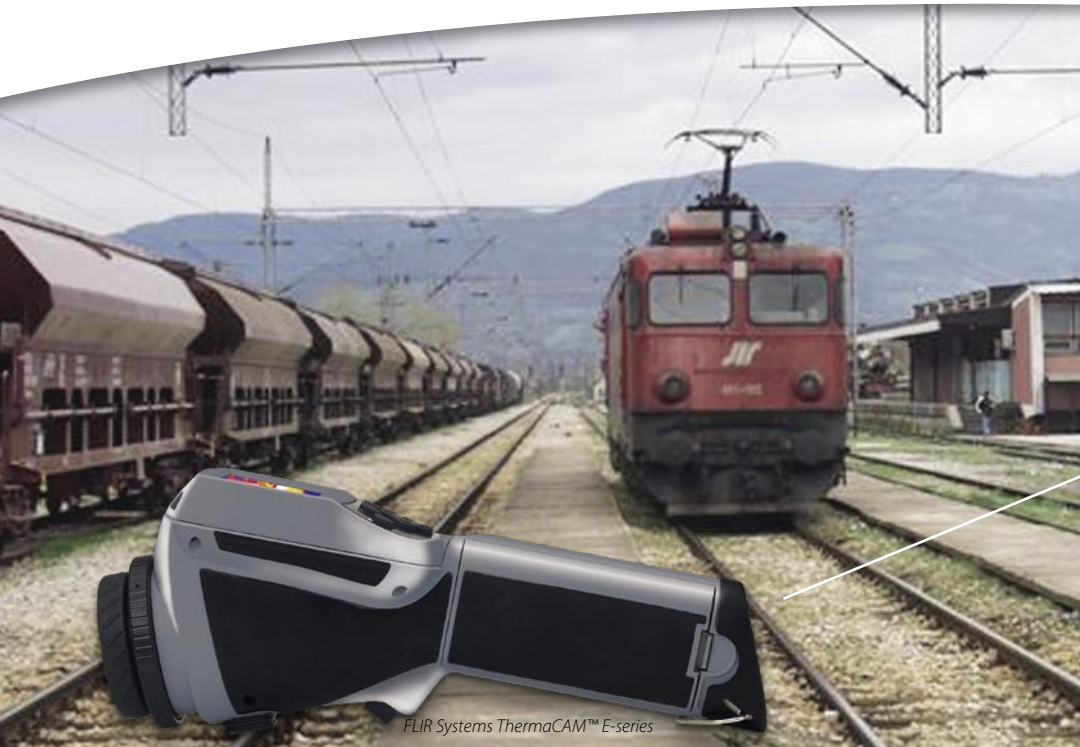
FLIR Systems ThermaCAM™ E-series

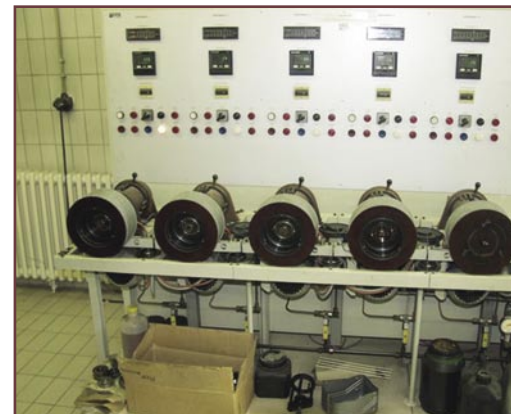
◆ Bearings on FAG FE9 test bed, ThermaCAM E-series linked to laptop

The ŽS experts chose infrared thermography as the most suitable non-destructive testing method, able to measure and visualize temperature developments over entire surfaces and over a defined amount of time. A set of bearings, lubricated with the same greases, was tested on a specific (FAG FE9) test rig for roller bearings lubricants. The test showed considerable differences in the heating behavior of the used and new bearings. But it became clear that the bearing had to be tested in real operational conditions to obtain convincing data on the leak origins.

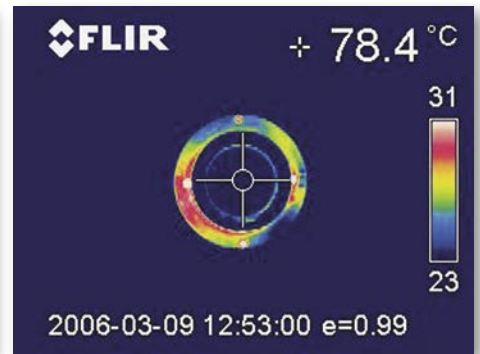
Heat development of new and old bearing, showing increased heat on outer ring
