APPLICATION STORY

FLIR Systems P and E-series infrared cameras reduce maintenance and repair time at Sweden's main distributor of Thermo King transport refrigeration

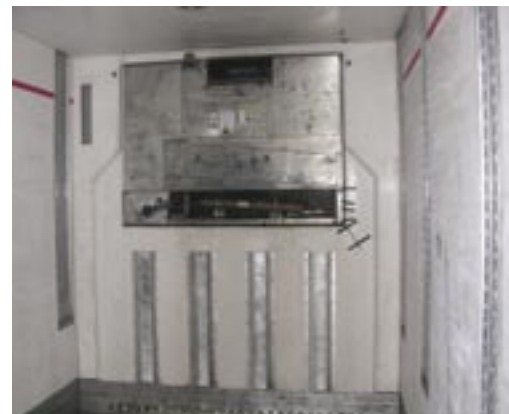
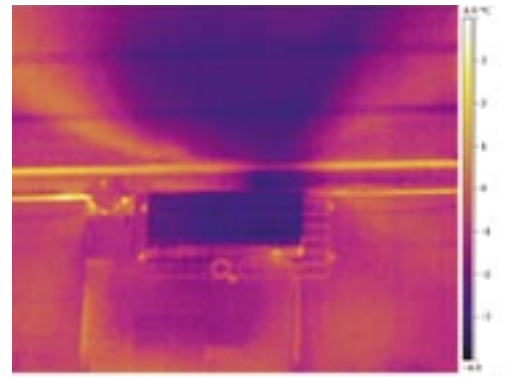
▲ Bad cooling in trailer: IR shows that discharge opening is blocked on the left side

A unit might be brand new and working flawlessly but not doing its main task : cooling goods as it should be. A careful thermographic outdoor and indoor inspection of the truck box

proves what's going wrong: either insulation problems (moisture intrusion), or thermal bridges, the intrusion of uncooled air into the transport box, or other reasons like blocked fans or condensers inside the box which obstruct the flowing of cooled air into the box. This inspection can be done with a low-budget infrared camera although more pixels helps to get a clear and convincing view of the problem.

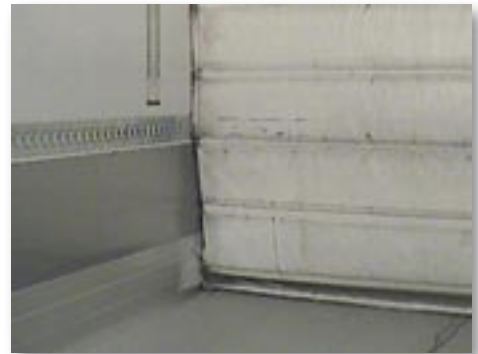
◆ Airleak in insulation curtain separating two temp zones in refrigeration box

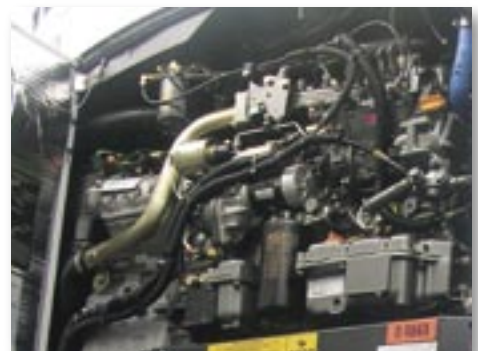
◆ Starter motor, oil filter of Thermoking fridge unit

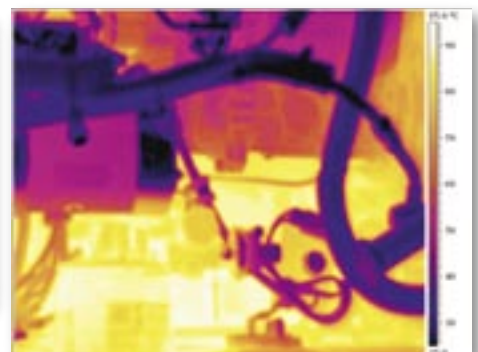
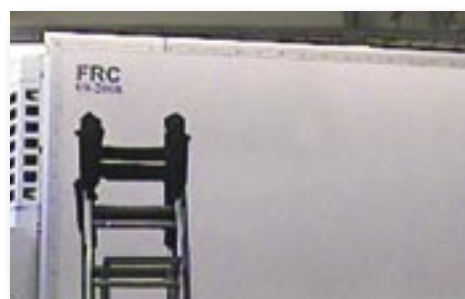
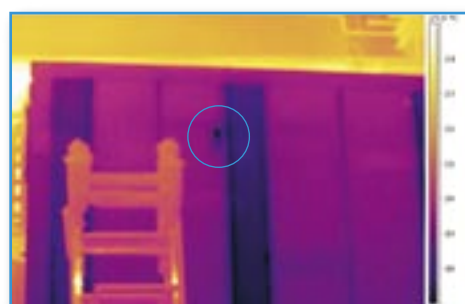
◆ IR image shows thermal bridges and a moisture spot in the insulation
