Test Report No.: 2007-3094

Subject: - Static load tests
 - Pendulum impact tests based on *TRAV*

Constructional element: fully glazed balustrades with HILTI® HIT-HY 70 bedding

Client: HILTI Entwicklungsgesellschaft mbH
 Hiltistraße 6
 D-86916 Kaufering

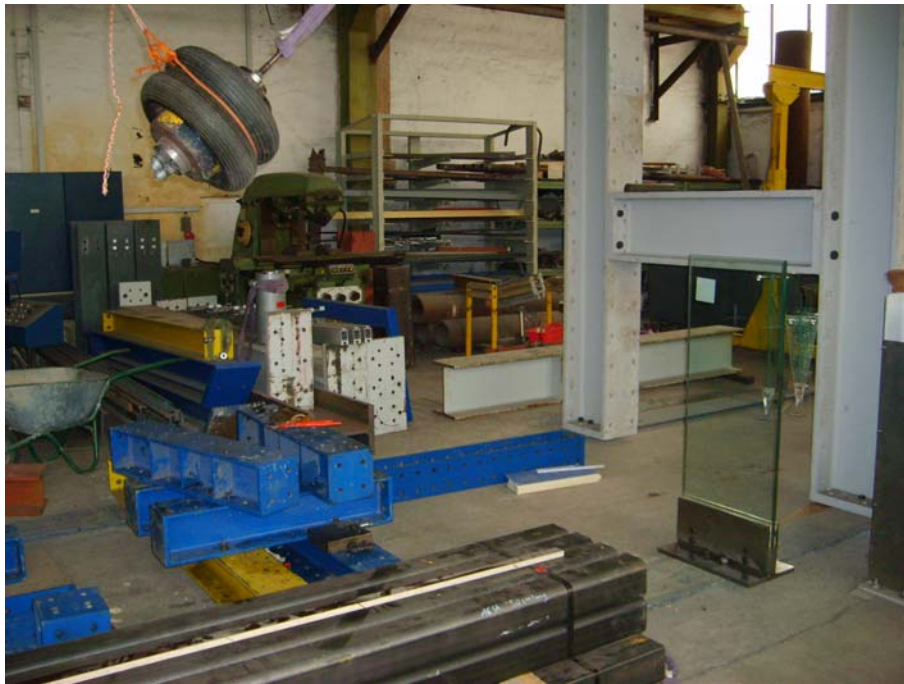
Test piece 1
Impact on P1 from a height of drop of $\Delta h = 900$ m
→ no damage

Impact actions 1 and 2 did not lead to any break of the pane. The test piece also withstood the other impact actions without any further breaks in spite of one sheet of the laminated safety glass being damaged. The pane remained fixed in its support. No broken glass fell down from the glazing. The HILTI® HIT-HY 70 bedding was not damaged.

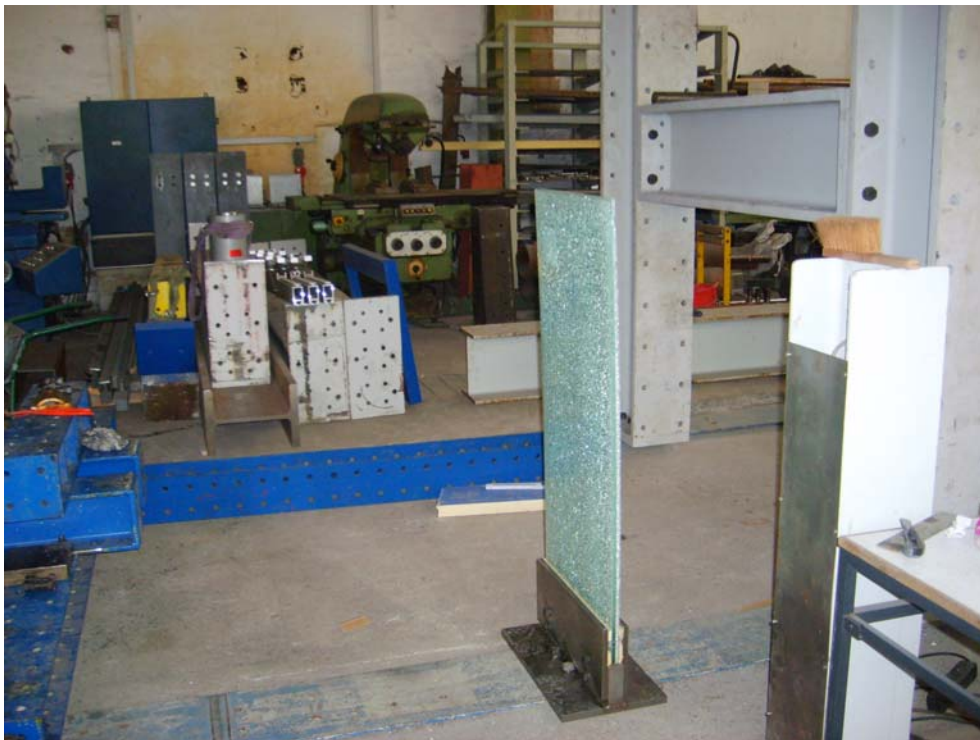
Test piece 1 after executing all impact actions

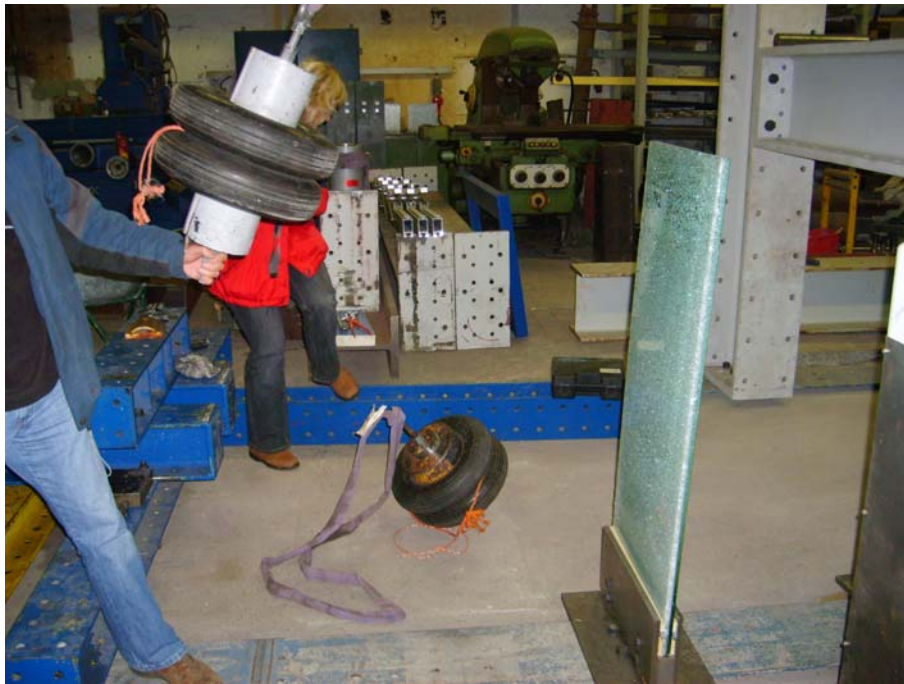
Test piece 3
Impact on P1 to test the residual load-bearing capacity; height of drop $\Delta h = 100$ m
→ no further damage

Impact actions 1 and 2 did not lead to any break of the pane. The impact on P2 by the pendulum destroyed the respective sheet of the laminated safety glass pane. The test piece withstood the other impact actions from a height of drop of $\Delta h = 100$ mm without any further breaks. The pane remained fixed in its support. No broken glass fell down from the glazing. The HILTI® HIT-HY 70 bedding was not damaged.

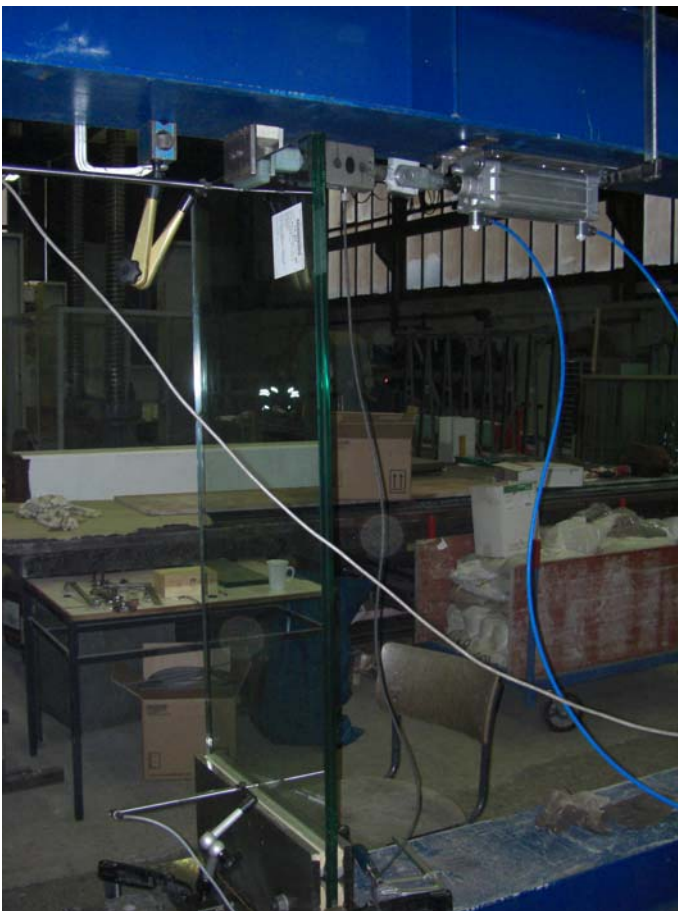
Test setup for the static load test of the glass support

To test the durability of the glass support with an HILTI® HIT-HY 70 bedding, steady load tests were executed on two railing balustrades. To this end, one point load corresponding to the load on the capping was applied via a pneumatic piston to the top edge of the glass in the centre of the pane. The deformation of the pane happened at the top and base points of the pane. The number of stress cycles (*Lastwechsel-Zahl*) was determined as 10,000 *LW*. The static load tests were carried out without the planned handrail. This led to a considerably higher deformation of the panes and thus to a higher load on the HILTI® HIT-HY 70 bedding than in the planned installation situation. The following sketch shows the test setup and the position of the deformation transducers.
